**Airport Pavement Paint Study
Implementation & Evaluation
Final Report**

1. Report No. FHWA-NH-RD-26962T		2. Gov. Accession No.	3. Recipient's Catalog No.
4. Title and Subtitle Airport Pavement Paint Study - Implementation & Evaluation		5. Report Date July 2020

Airport Pavement Paint Study - Implementation & Evaluation

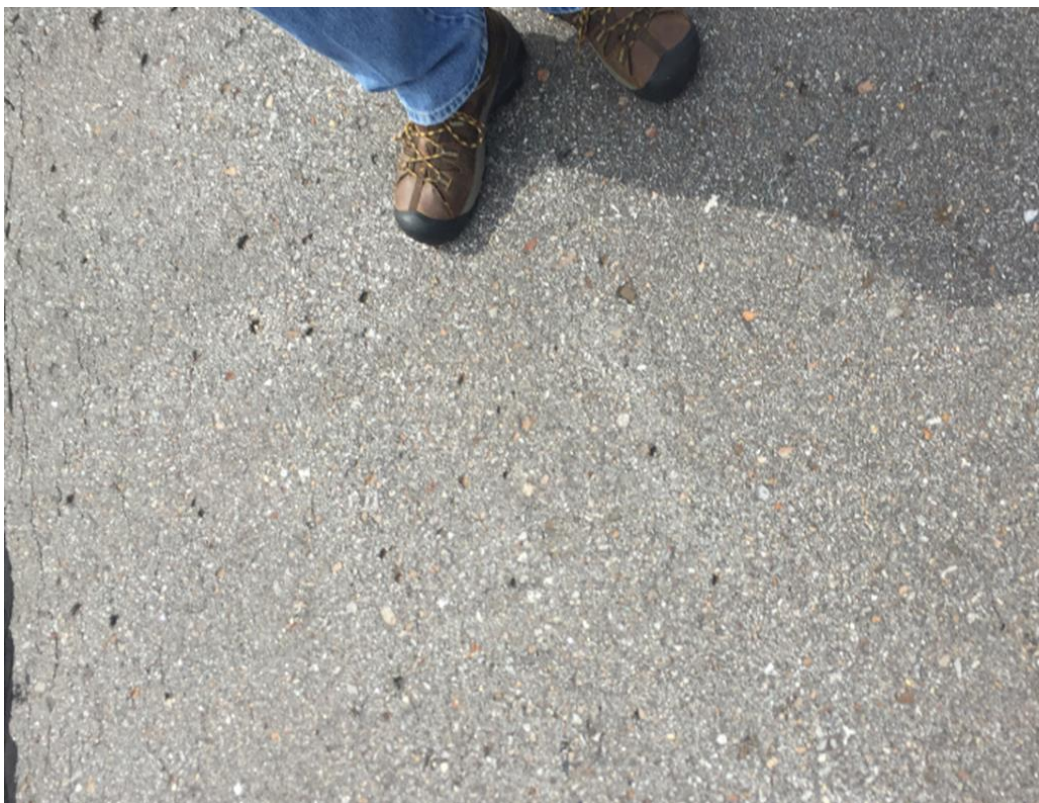
Figure 5: Loss of Aggregate in Runway Surface

The runway pavement condition index (PCI) values were obtained in 2012. The PCI study indicated low to moderate raveling of the pavement aggregates. The raveling is shown in Figure 5. In the figure, the dark spots in the pavement are the small holes (i.e., raveling) where the pavement aggregate has eroded. The raveling is attributed to deleterious pre-weathered aggregates in the bituminous concrete surface⁴. These aggregates decomposed when exposed to the elements. The result of the aggregate weathering are small pockets or holes in the pavement surface. In the Runway 26 seal coat area of the study (area G), the 2012 PCI was estimated at a 46 rendering the pavement in fair condition prior to application of the seal coat. In study areas 1 through 4, the PCI ranged from 74 to 95. These values describe a very good pavement condition.

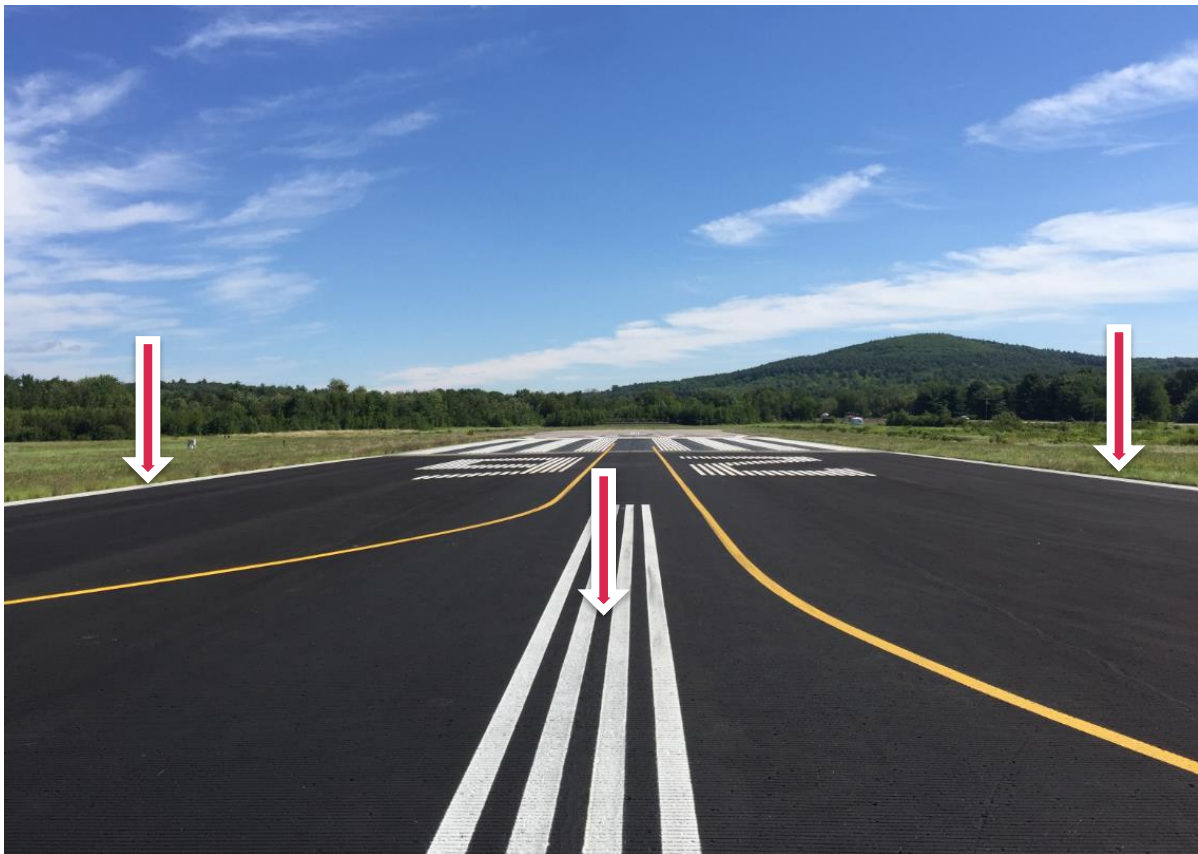
Figure 8: Relationship of Runway Centerline to Edge Stripes

Of all the runway markings, the edge stripes have the largest volume of stormwater flowing over them. The runway is normally crowned with the high point along the runway centerline. The edge stripes start 47 feet away from the runway centerline and the pavement at the edge stripes is 6 inches lower than the runway centerline. This makes it a worst-case location as it has the highest rust loading from the stormwater flowing over one half the width of the runway pavement as well as the opportunity for bottom up rust spot staining. Additionally, if the study paint resulted in significant color changes, the edge stripes were considered as lower priority markings on the runway and therefore a lower safety issue.

The location of the edge stripes is on un-grooved pavement. The runway is grooved with grooves extending 40 feet on both sides of the centerline. The runway grooves expose the aggregates in the pavement from the saw blade cuts. This exposure causes direct contact between the iron in the aggregates and the stormwater. This contact increases the opportunity for the rust to become a solute in the stormwater and flow over the study's paint in areas 1-4. Area G's runway grooves were coated with the P-608 seal coat which reduced the concentration of rust in the stormwater flowing over the area G paint.

Area G ('G' for the Gilsonite in P-608) or the fifth area was selected for its application on the seal-coated surface. The black seal coat is evident in Figure 8. Area G is approximately 900 feet east of the areas 1 through 4 and was paved under the same project as areas 1 through 4.

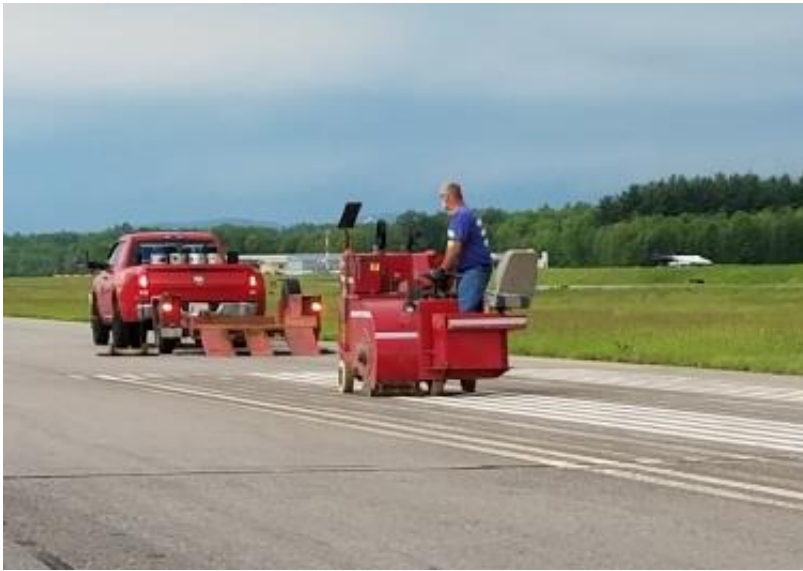
Figure 10: Runway Paint Removal

In study areas 1 through 4, the bituminous surfaces were prepared by grinding the existing paint. The surfaces where the paint was removed were further prepared by sweeping and blowing prior to painting. In area G, the existing paint was removed by grinding and then seal coated with the FAA Specification P-608 seal coat by APS under the airport-contracted project. The seal coat cured 115 days before the study's paint was applied, well beyond the FAA P-620 30-day typical cure time.

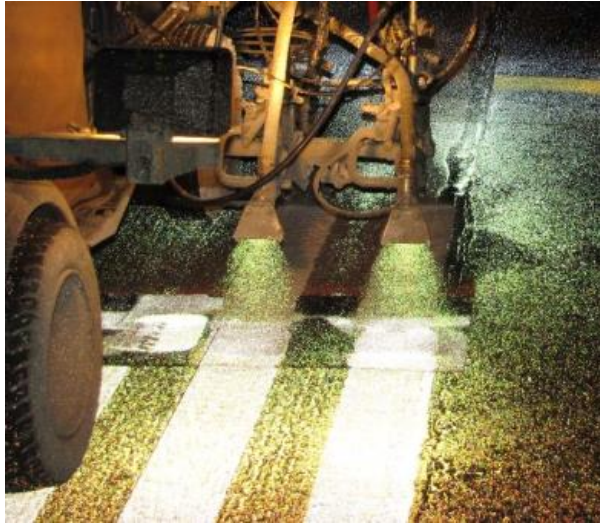
Figure 11: Paint and Bead Installation

Prior to the installation each paint applicator was calibrated to the specified paint and bead application rates on the airport's abandoned runway pavement. Paint was installed with self-propelled, ride-on Graco paint machines that were equipped with automatic, pressurized glass bead dispensers.

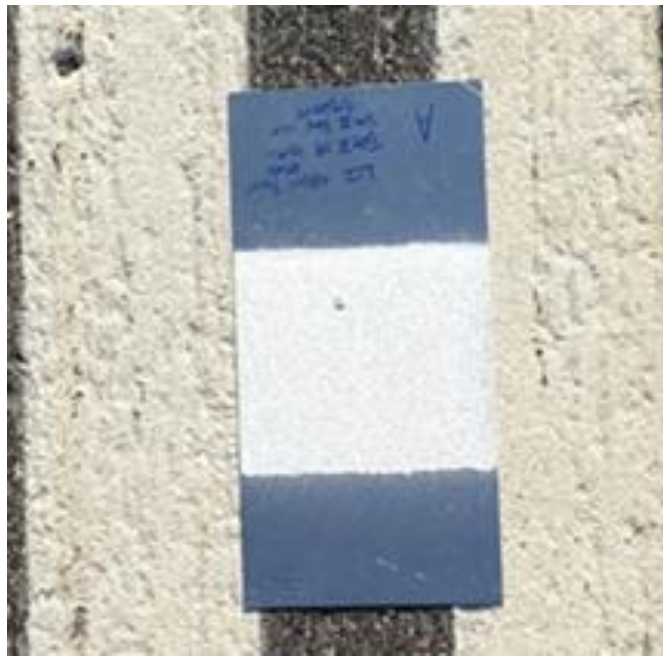
Figure 16: Control Sample Placed Next to Field Paint

At each visit the paint color was photographed using an iPhone 6. The control panel collected during the paint installation was brought in its protective envelope from Jacobs' office to the field. The sample was placed on the pavement next to the sample paint location and photographed. Each area had its own control sample for that area's paint and bead type. The same sample was placed at all four sample locations in each area. The time of year and time of day provided different light intensities for the photographs. Some photographs with less than optimum lighting appear darker. The less than optimum lighting did not impact the study comparisons when the photographs are compared over the 24-month study period.

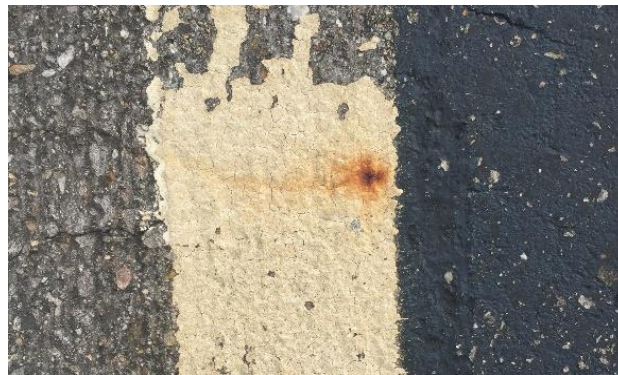
Figure 17: Bottom-up Rust Spot Stain

Bottom-up rust spot stains were counted along the first in-board stripe of each area. The count was made by walking the line and if a rust spot stain could be observed at eyelevel, it was counted. The size ranged from the diameter of a pencil eraser to a U.S. nickel. A typical bottom-up rust spot stain can be seen in Figure 17.

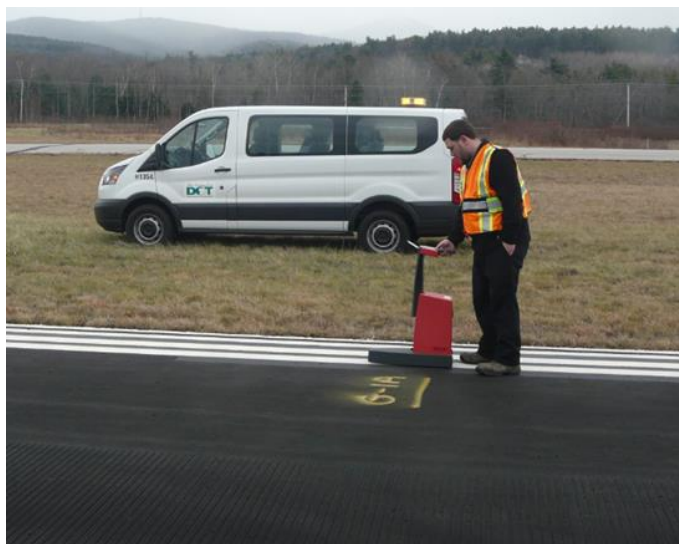
Figure 18: Retroreflectometer Reading

this equipment. In addition, the NHDOT offered the use of the equipment at no additional cost to the study. Trained personnel from the NHDOT Bureau of Materials and Research operated the calibrated retroreflectometer and provided the readings. The retroreflectometer used was LTL-X Mark II manufactured by DELTA. The NHDOT readings are provided in the Appendix D.

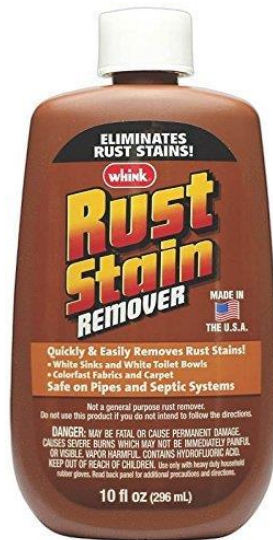
Figure 20: Rust Remover

After the first year of field observations, the study's inspectors noticed the discoloration of the paint was becoming darker with time. Various sources of contamination from dirt, algae and rust were considered. To prove the source of contamination, select sites in each area were scrubbed with soap and water or a rust remover was applied. As soap and water made no change to the paint discoloration, the soil and algae contamination possibilities were eliminated. The application of a commercially available rust remover (Figure 20) resulted in a rapid removal of the contamination on the paint, confirming that the paint contamination was rust. Figure 21 shows the white paint next to where the rust remover was applied. It is noted that the rust staining is only on the surface of the paint. The rust is not within and did not damage the paint. Additionally, the bottom-up rust spot stains were removed with the rust remover.

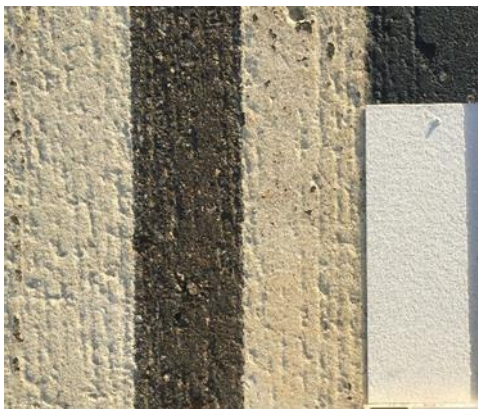
Figure 22: Area 1 II SR/III

It was observed that over the 24-month period all paint test areas’ color deteriorated, changing from white to brown undertones. The paint stripes observed on September 26, 2019, the last observation at the end of the 24-month study period, for each area can be seen below in Figures 22 through 26 along with their associated control panels:

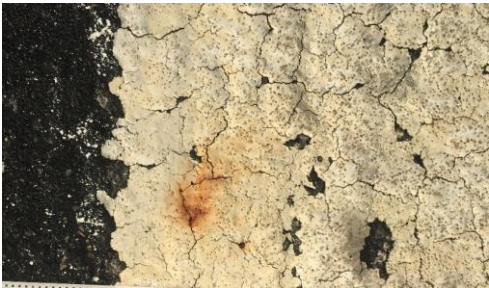
Figure 32: Rust Spot Stain in Area G

The number of bottom-up rust spot stains were plotted as stains per 100 feet, as each area had a different length. The average number of rust spot stains counted during the 24-month period is shown in Figure 33. These stains are not related to the rust laden stormwater sheet-flowing over the paint. These rust spot stains originate from below the paint.

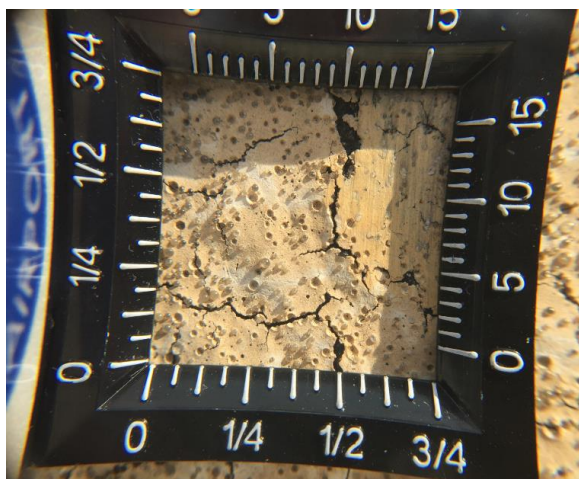
Figure 38: Area G - Sample 2 – 9/26/19

To further illustrate the poor bead embedment in area G, a comparison of areas G and 1 are shown in the Figures 38 and 39 below. Area G has numerous missing bead craters as compared to area 1 with the beads mostly intact.

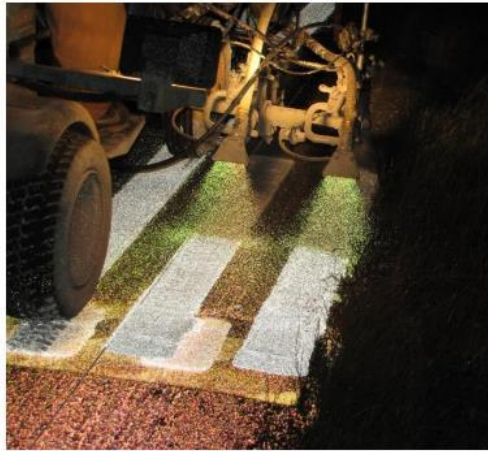
At 7:30 pm, people began to arrive. A crew began removing the areas of runway edge markings that would receive the test lines, equipment was loaded with material, and the paint machine was calibrated for the TT-P-1952E, Type II stain-resistant paint from Safety Coatings, Batch Number BO7728. A 1 quart sample was taken and given to Tim Buzinski to retain for the period of the NHDOT test. Jeremy Cunningham, the striping machine operator, determined his speed to be 1.5 mph when 15 mils wet film thickness was achieved. The glass bead guns were then calibrated to collect 150 ml of TT-B-1325D, Type III glass beads in a 10-second drop for the 5-inch line. Once the bead guns were both calibrated, the equipment was taken out to the runway. The area that had been removed was checked to ensure it was clean enough to paint, and additional blowing and sweeping had to be done to remove the majority of the residue left in the depressions in the pavement. The crews held a string line for the length of the test area ^{east} ~~west~~ of Taxiway F on the ^{north} ~~south~~ side of the runway; and Jeremy painted the first two of four 5-inch lines. During the first run, it was noticed that the bead guns were not adjusted properly to drop the majority of the beads on the painted lines. Jeremy adjusted them to get more of the beads on the lines, seen in Pictures 1 and 2 below.

Picture 1 – glass beads spreading too wide.

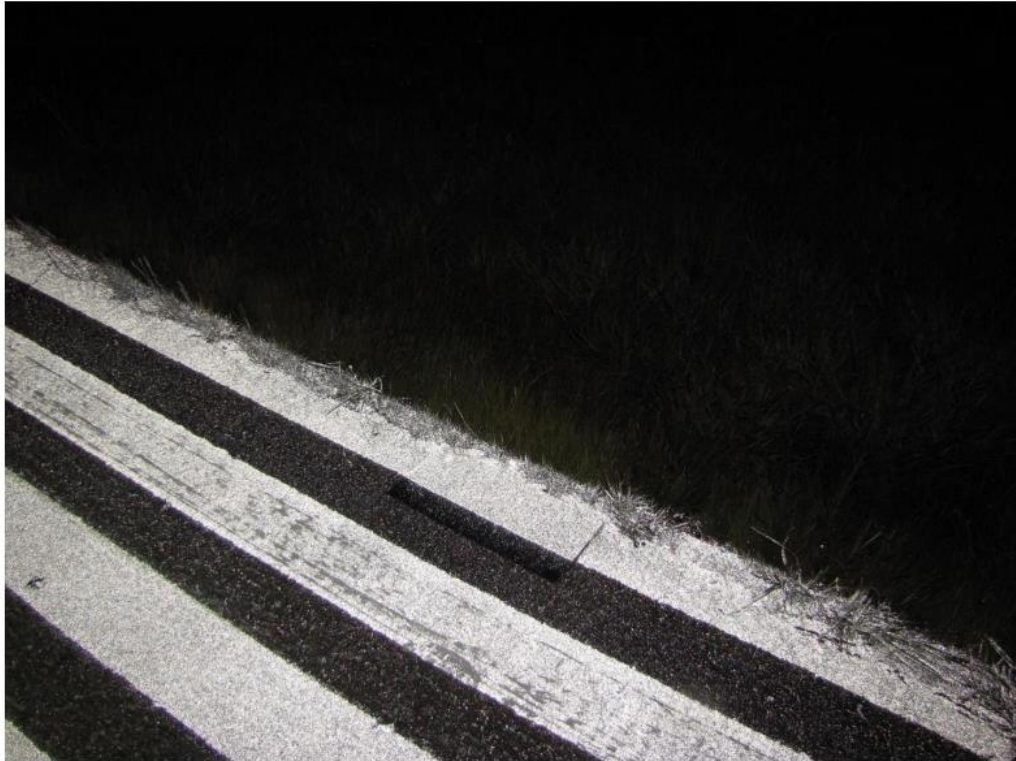
Once the initial test lines were dry, Jeremy proceeded to apply the other two of four 5-inch test lines using the Type II stain resistant paint. Tim Buzinski collected the two panels that were placed along the test lines that would be retained for the duration of the research project. The first test line that was applied had a clogged glass bead gun (Picture 3). Jeremy recognized it, stopped, then went back to the beginning and applied beads over the unbeaded line (Picture 4). The second panel was placed longitudinally along the line closest to the grass, seen in Picture 5. The streaks seen in the line next to the outermost line were from the string line that rolled across the freshly painted line.

Picture 5 – Test panel placed longitudinally along outer line closest to the grass.
